# PERKIOMEN TOWNSHIP

## Highland/Huber Park Draft Master Plan

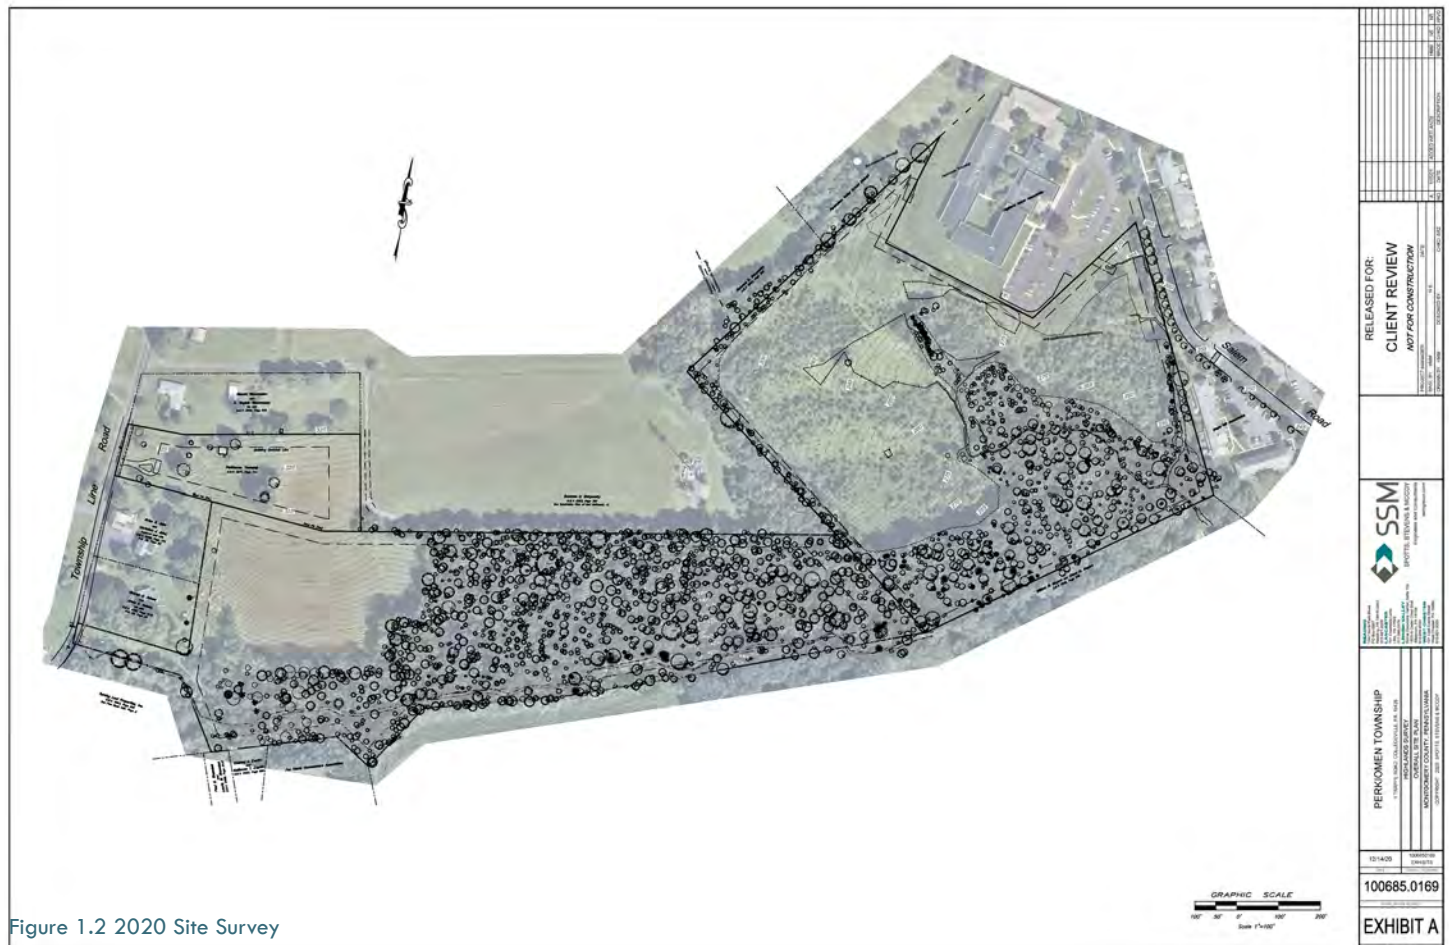
Figure 1.2 2020 Site Survey

Elements for this plan were compiled using the best available information. This information included a site survey conducted by Spotts, Stevens & McCoy Engineers and Consultants dated 12/14/2020 (Figure 1.2), Geographic Information System (GIS) data, and Pennsylvania Spatial Data Access (PASDA), aerial photography, and site reconnaissance visits.

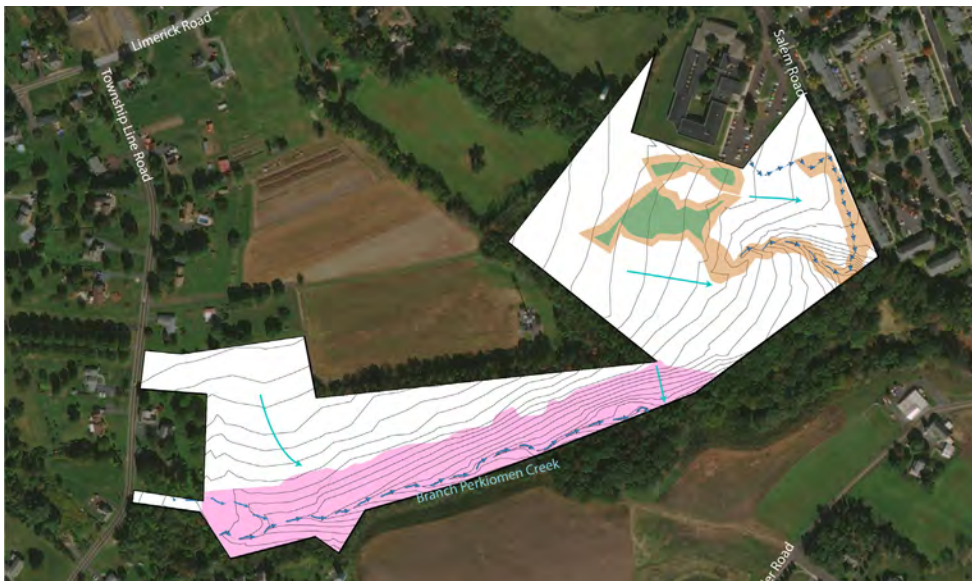
Figure 2.6 Hydrology Analysis Map

The site falls within the Lower Perkiomen Creek Watershed. The Perkiomen Creek is 37.7 miles long in Berks, Lehigh, and Montgomery County, and creates a western border of Perkiomen Township. A Branch of the Perkiomen Creek runs at the southern edges of our site, flowing to the east, as a first-order stream. According to the Bog Turtle Assessment completed by Liberty Environmental, four (4) wetlands and six (6) watercourses can be found in the eastern area of the site.

The concrete headwall in the northeastern portion of the site sends all the runoff collected off the Highland Manor parking lot into the park site. The water coming out of this headwall has formed its own drainageway, which flows south along the eastern edge of the property until it reaches the southeastern corner, where it intersects with another drainageway flowing down to the Branch of the Perkiomen Creek. The stretch before the intersecting location shows signs of major erosion. This

Two (2) smaller wetlands situated north and south of one another can be found to the east of the largest wetland. These wetlands are PEM wetlands, and both measures approximately 3,700 square feet. Indicators of hydrology include geomorphic position, drainage patterns, oxidized rhizospheres on living roots, and saturation for the northern one, and saturation, geomorphic position, and drainage patterns for the southern one. Hydrology is provided from surface water and groundwater for the northern one, and just surface water for the southern one.

The smallest wetland can be found to the west of the largest wetland. This wetland is a PEM wetland, and measures approximately 220 square feet in size. Indicators of hydrology include geomorphic position, surface water, and saturation. Hydrology is provided from surface water.

The other prominent watercourse runs south from the southern point of largest wetland to the Branch of the Perkiomen Creek. Most of this watercourse is found to have erosion. This watercourse has been classified as a high flow intermittent channel that is approximately one (1) to four (4) inches deep and six (6) inches to two (2) feet wide with a gravel, cobble, and boulder substrate.

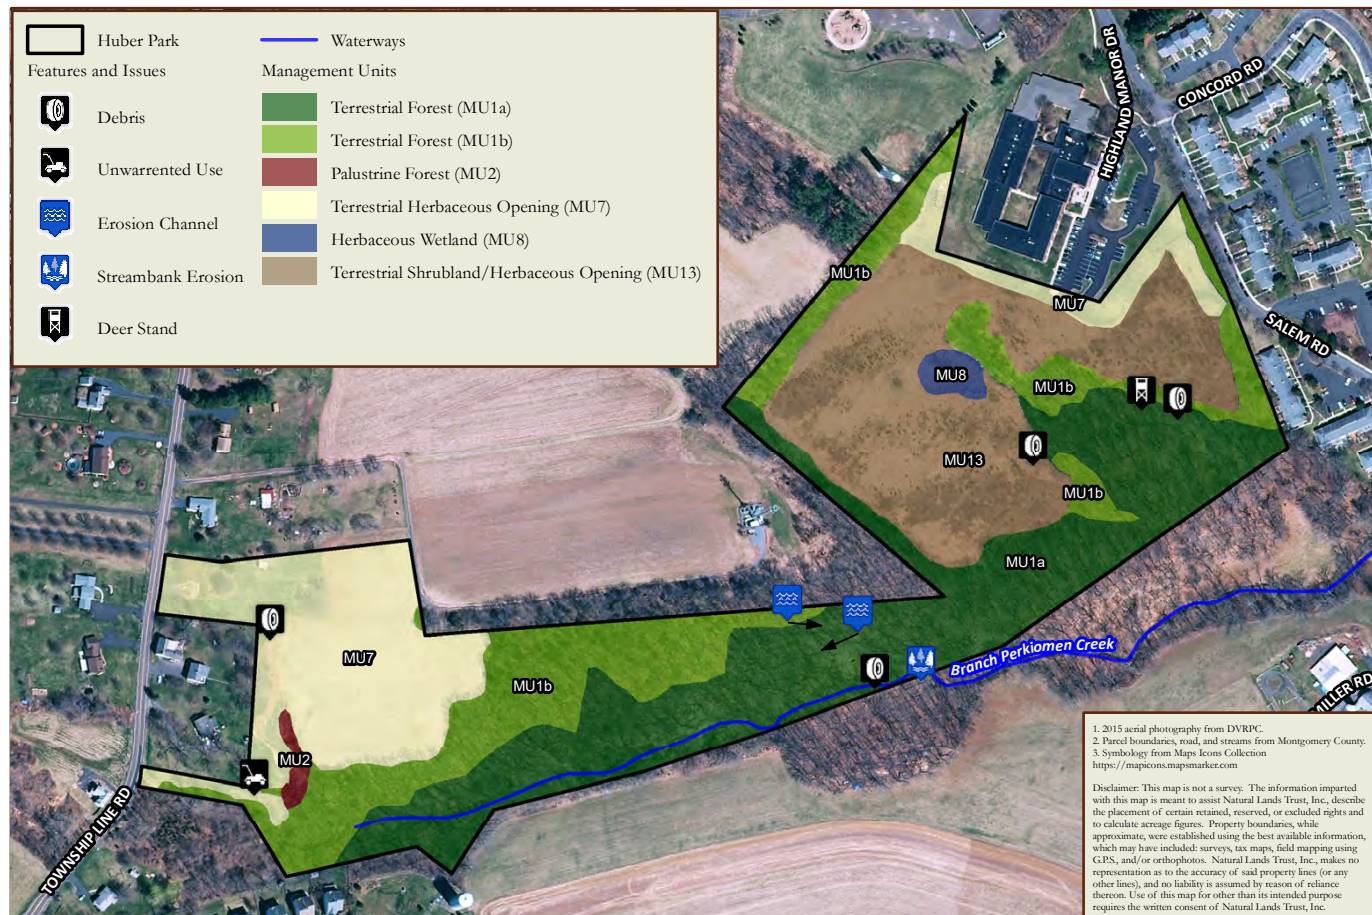
Figure 2.7 Municipal Stewardship Assessment Management Unit/Vegetated Map

Palustrine Forest (Red Maple Palustrine Forest) is approximately 0.18 acres in size and identified along the western edge of the site, and within the largest identified wetland. This forest is a mix of canopy, shrub and vine, and herbaceous. The dominant plant species are a mix of native and invasive plants. The native plants within this forest type include, but are not limited to: red maple, sensitive fern (*Onoclea sensibilis*), iris (*Iris* sp.), and jewelweed. The invasive plants in this forest type include but are not limited to: multiflora rose.

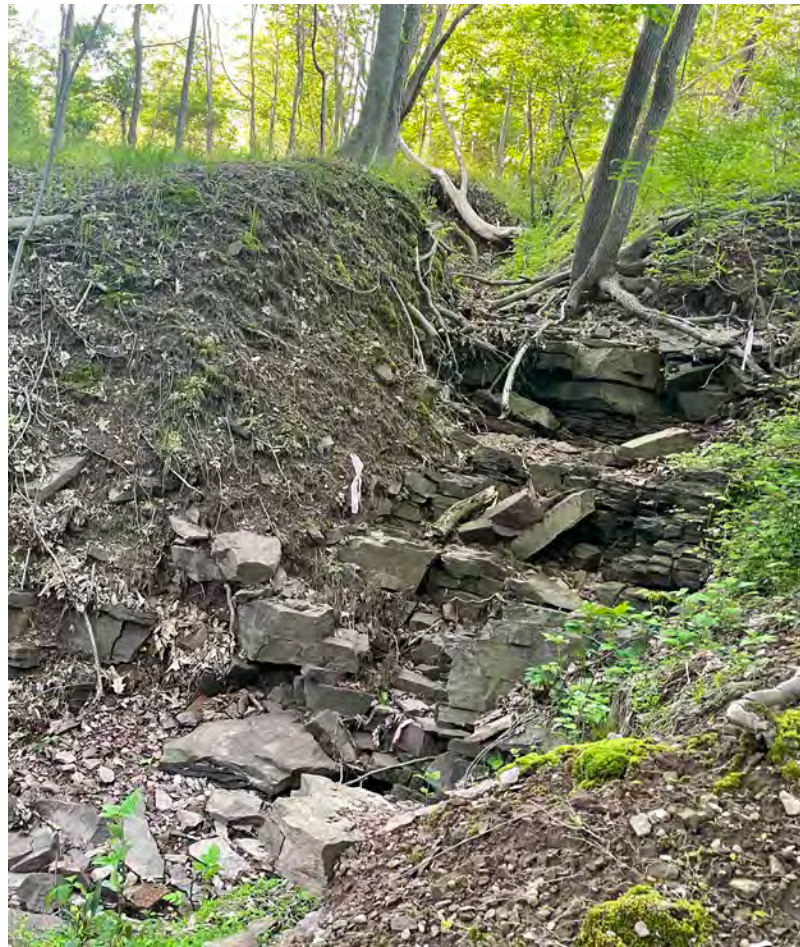
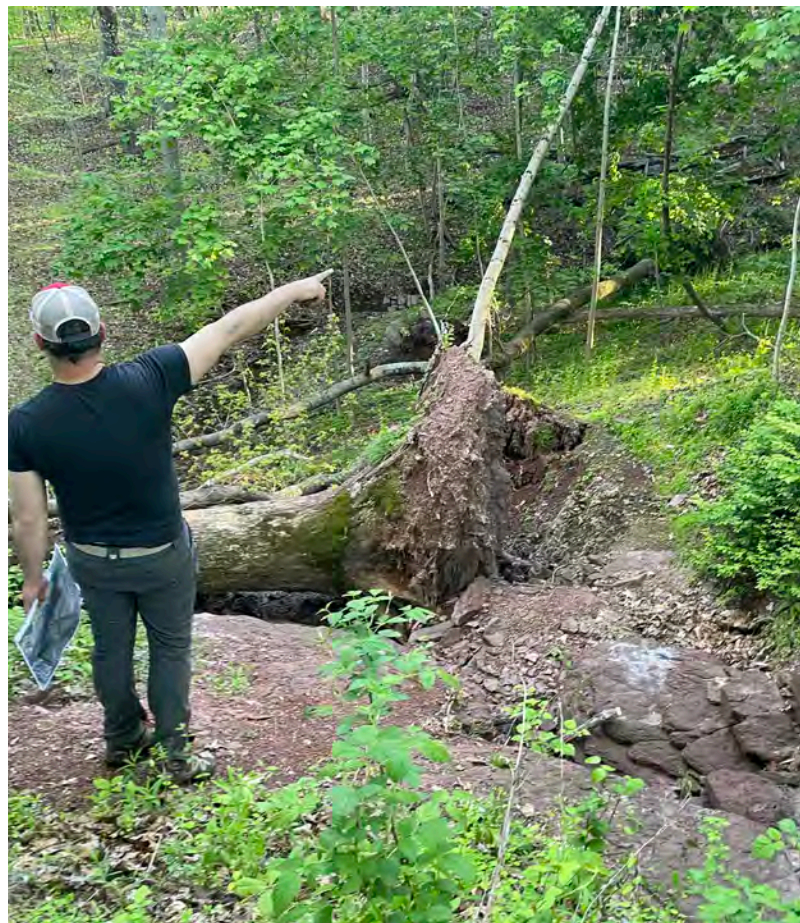
Eroded stream that flows down to the Branch of the Perkiomen Creek

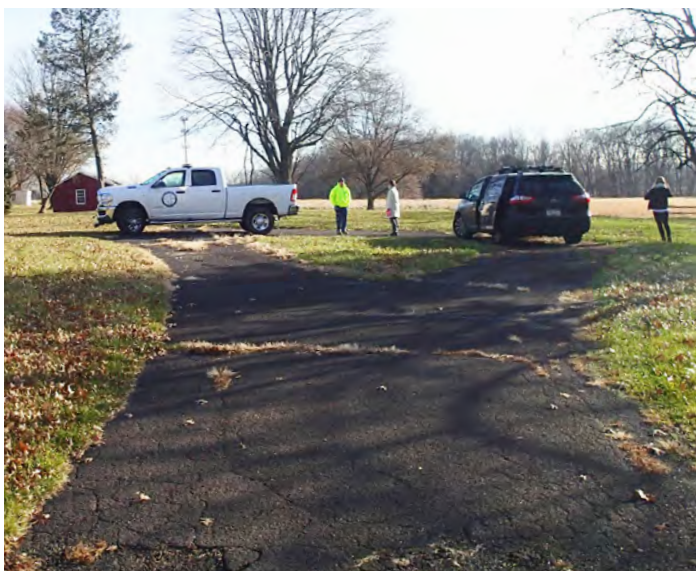
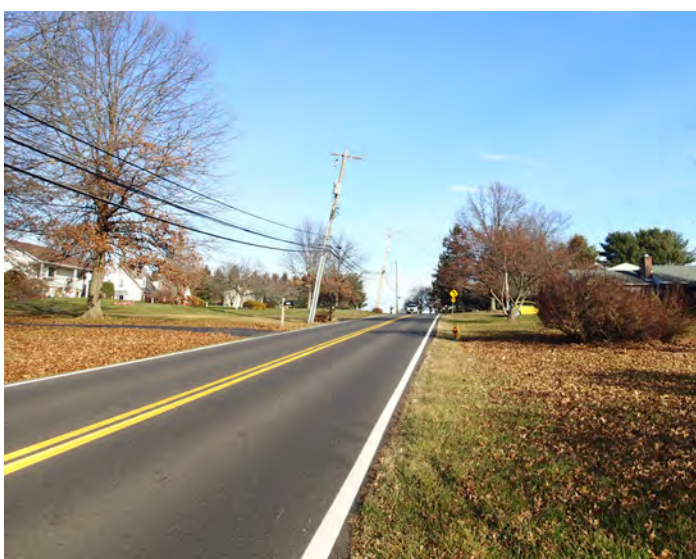
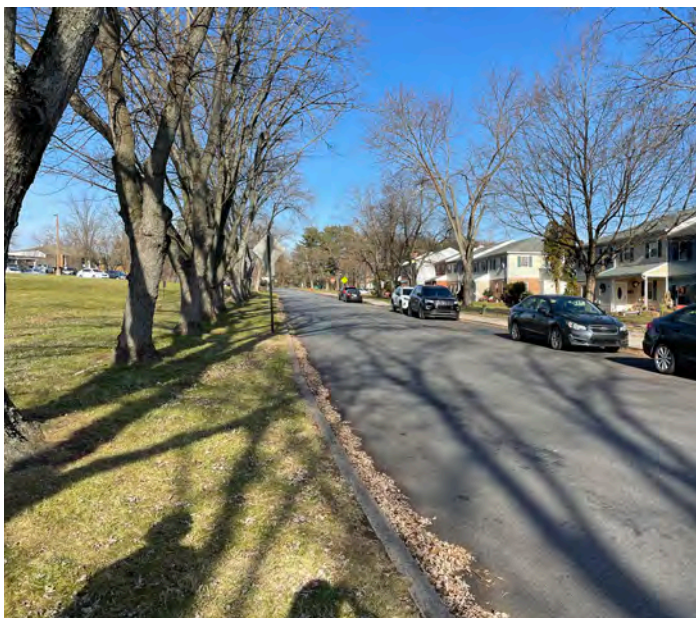
Photos of current access into the site from Township Line Road, view shed north on Township Line Road, and viewshed north on Salem Road (from top to bottom)

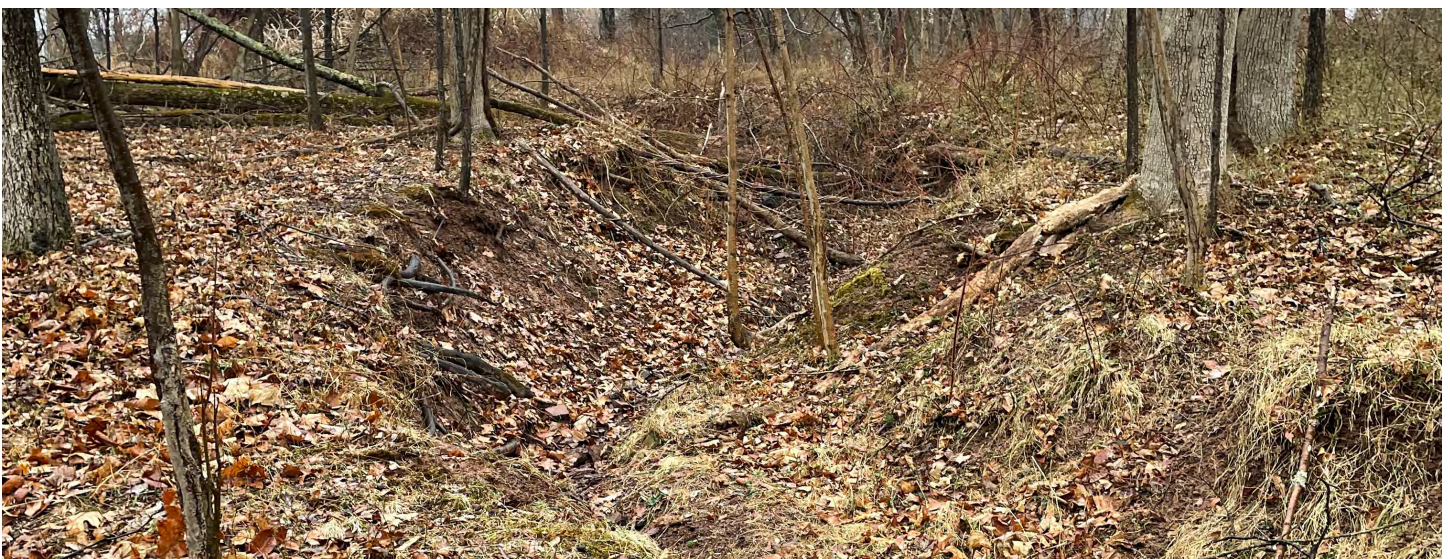
Development of native plant riparian buffer will help reduce erosion and increase wildlife habitat.

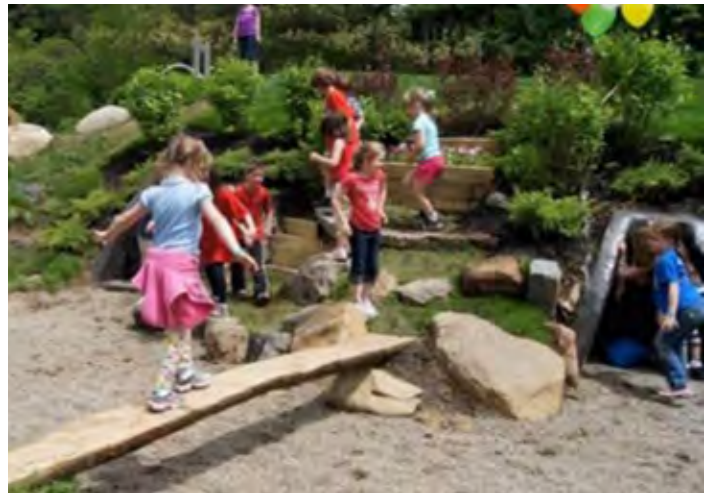
Natural elements, such as logs, boulders, mulch and grass mounds are commonly used in Nature-Based Playgrounds.

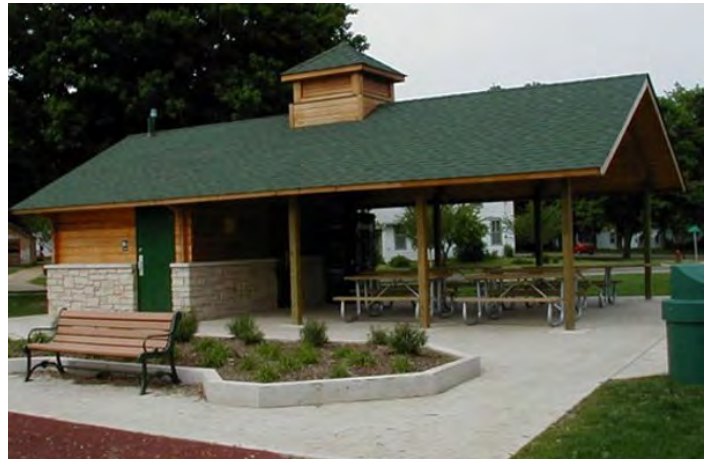
An example of a classic park pavilion with restrooms and storage provided within the enclosed area.

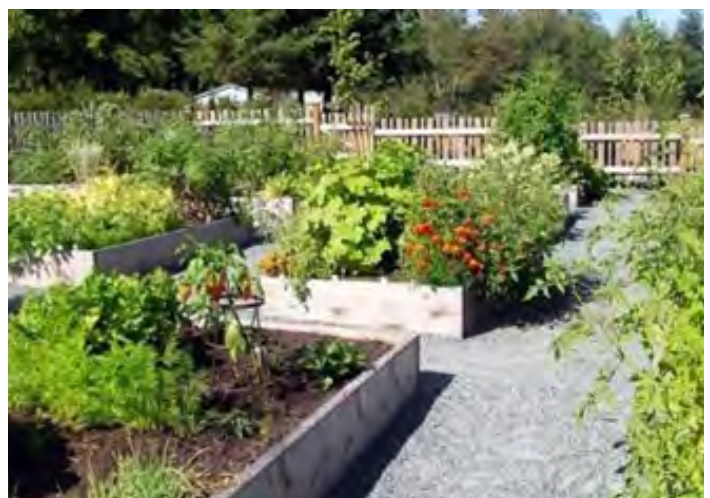
Raised wooden beds with a crushed gravel walking surface is one example of how a community garden may be designed.

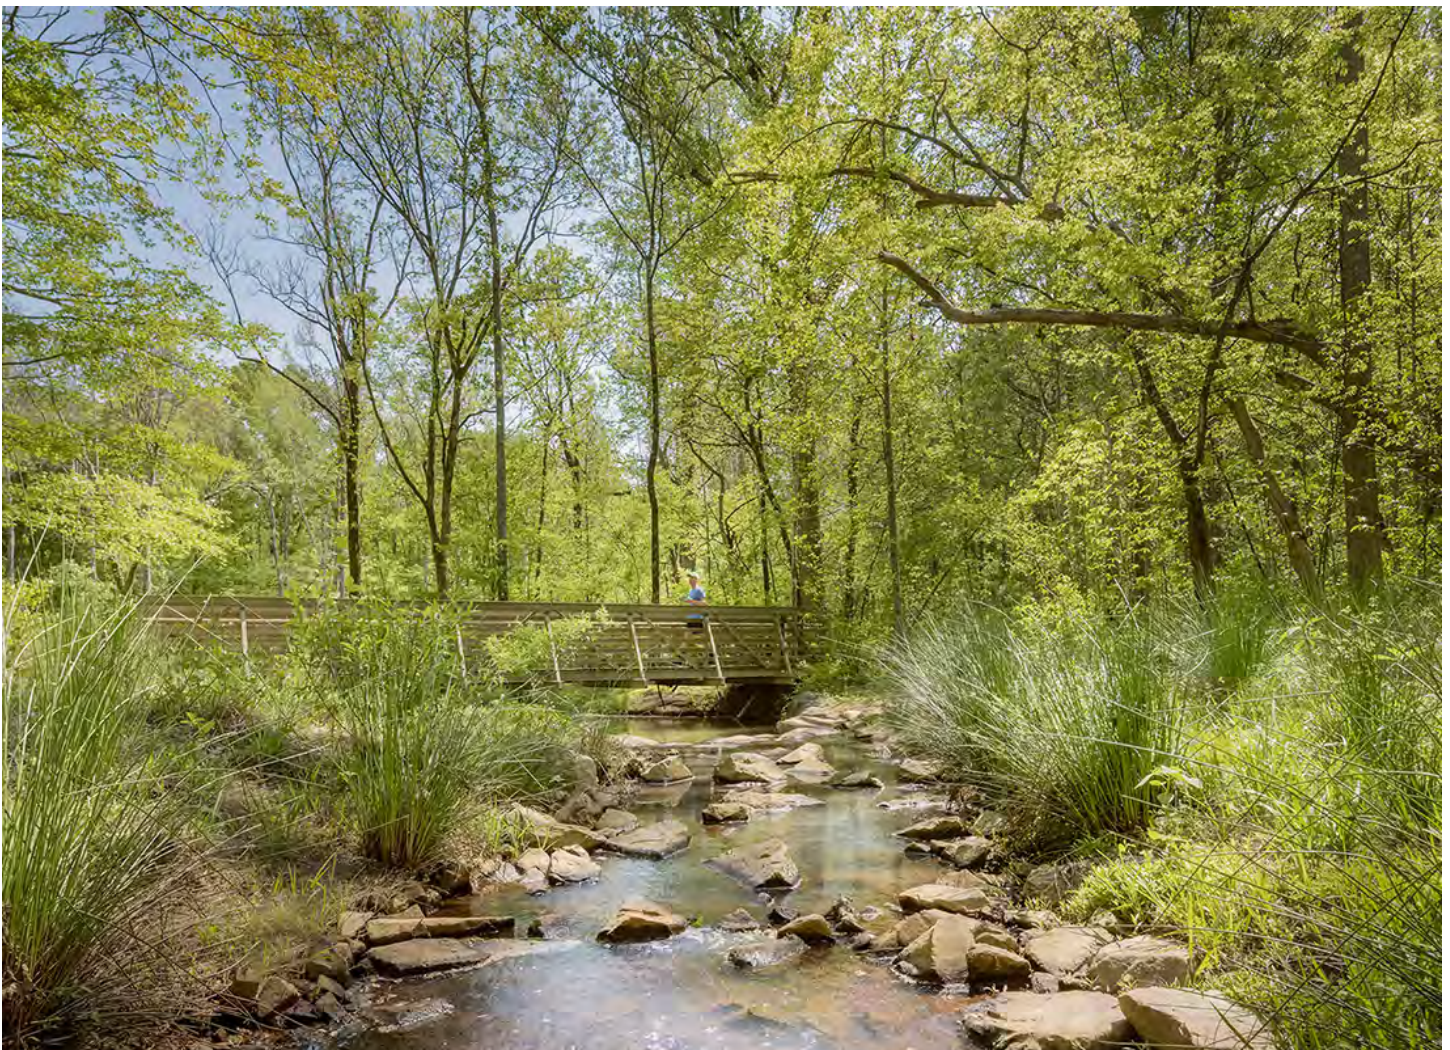
Streambank restoration can include rock check dams and embankment plantings.

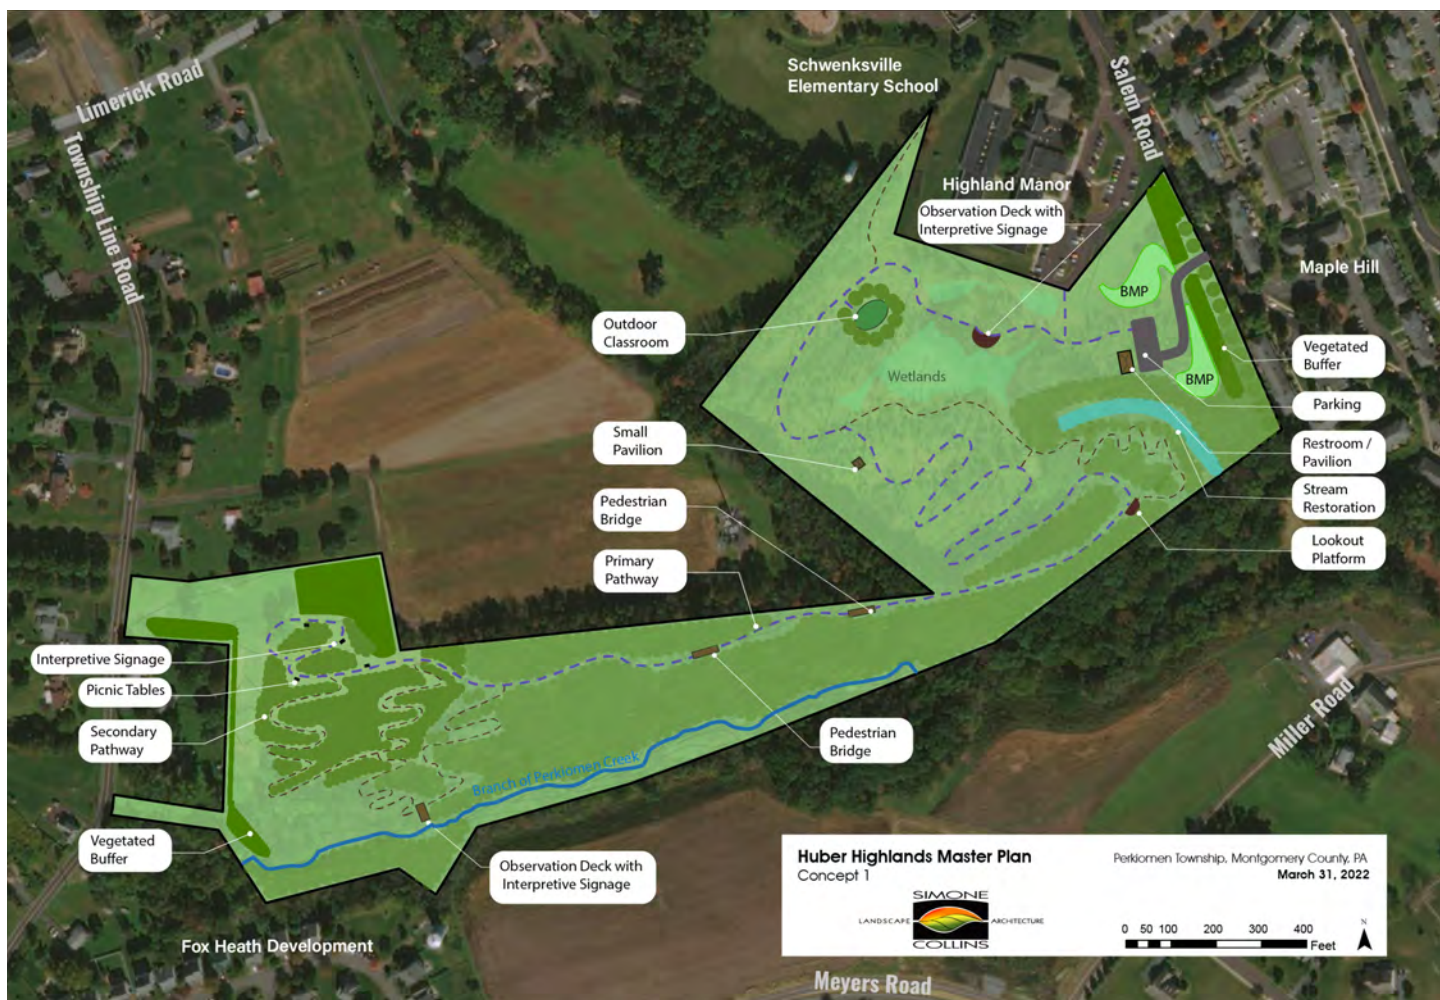
Figure 3.1 Concept Plan 1

On the west side, there are minimal amenities. The space primarily functions for hiking, contains small picnic areas and observation areas over the Creek. In order to screen these amenities from the neighboring residents, a heavy vegetated buffer is proposed along the properties, and the existing meadow is proposed as restored woodlands.

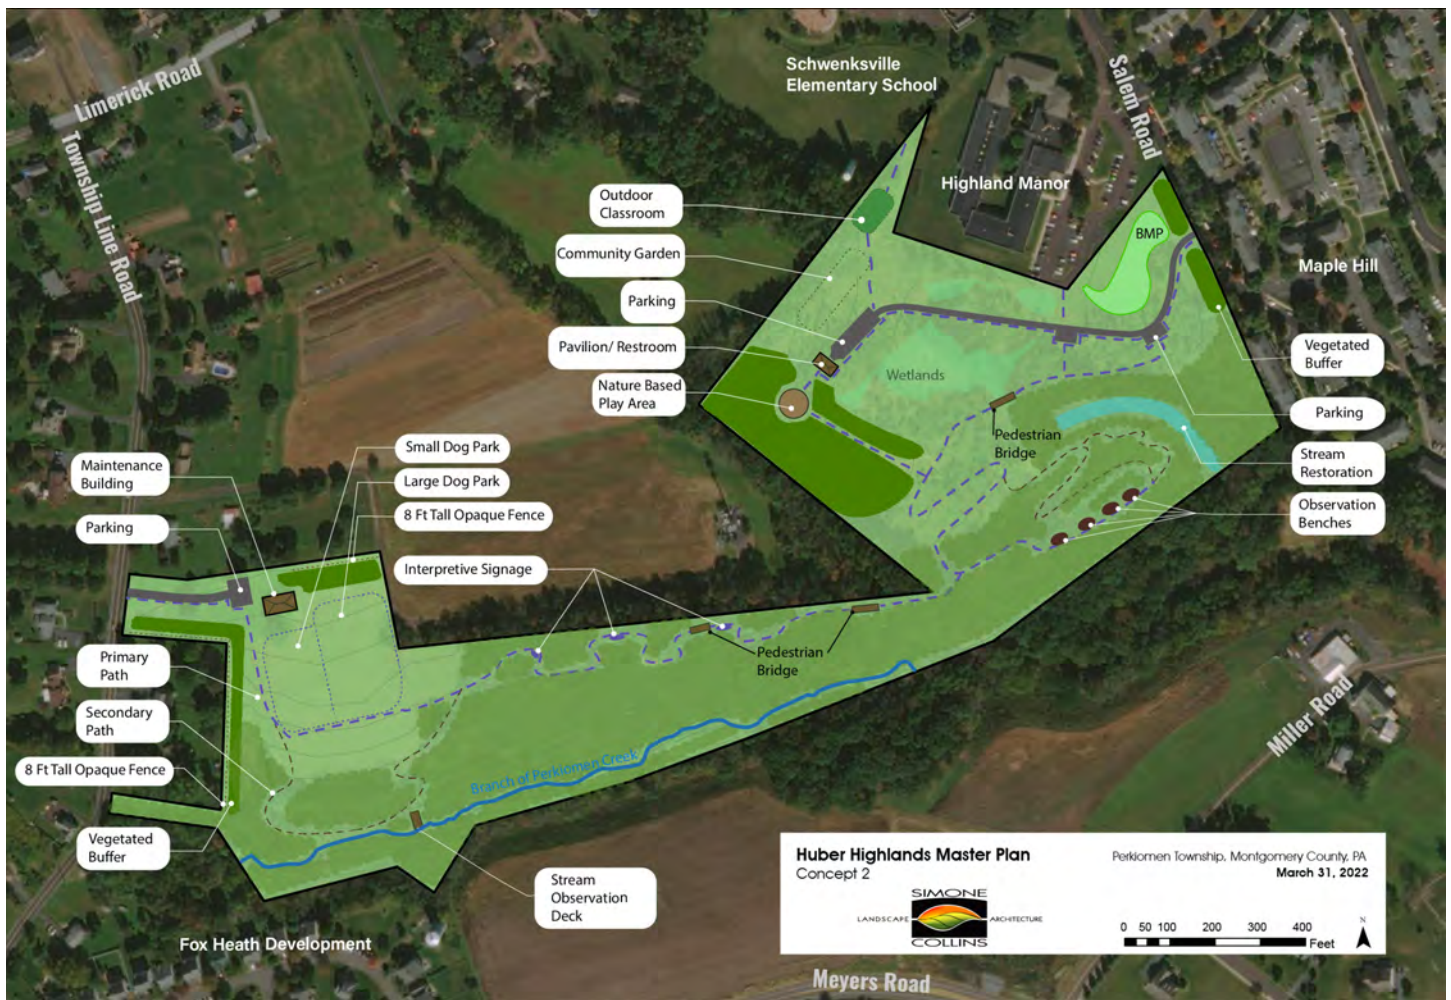
Figure 3.2 Concept Plan 2

A dog park is situated adjacent to the maintenance building. The large dog park is sized at slightly above 1 acre and small dog park just below 1 acre and are located in the western area of the site. Along the property line adjacent to the dog parks is an 8-foot-tall opaque fence and a vegetated buffer to shield views and noise from the adjacent residents.

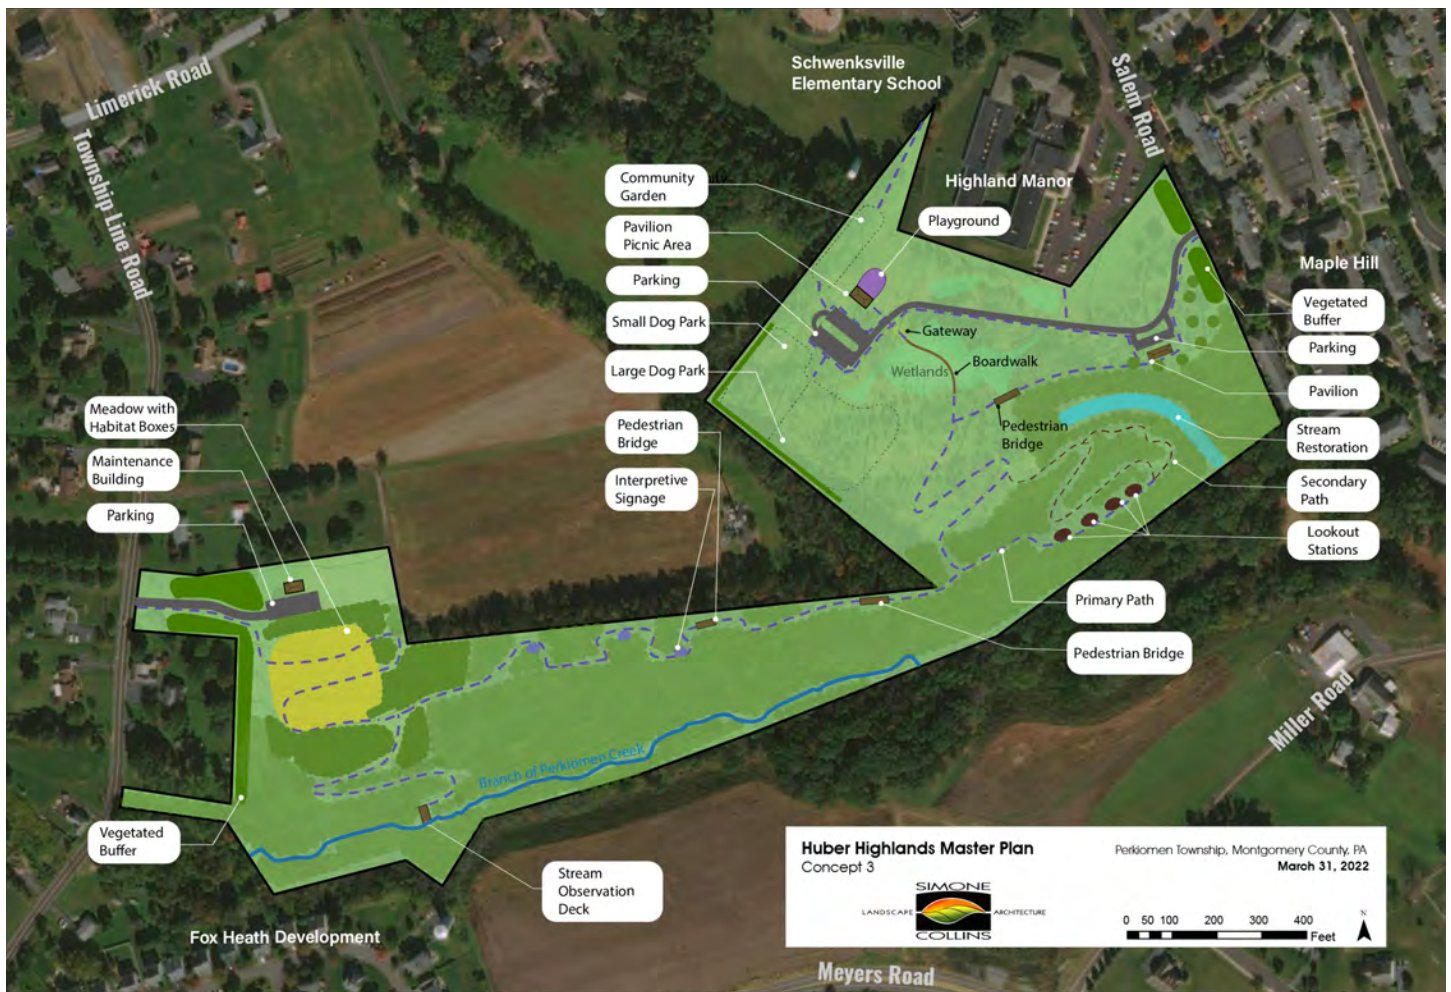
Figure 3.3 Concept Plan 3

### Concept 3

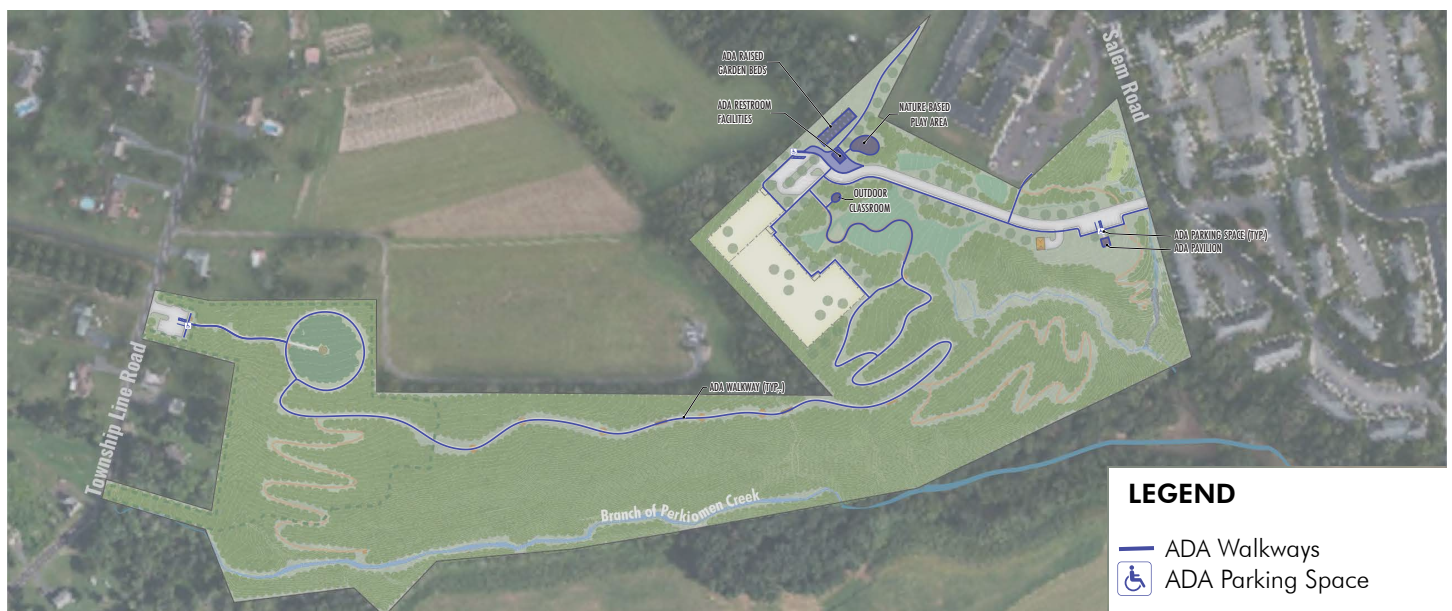
Figure 3.4 ADA Plan

- Vehicular access from Township Line Road
- Parking Lot – 9 spaces (1 ADA)
- Reforestation Area
- Food Forest
- Picnic Area with furnishings: trash receptacle, and four (4) picnic tables

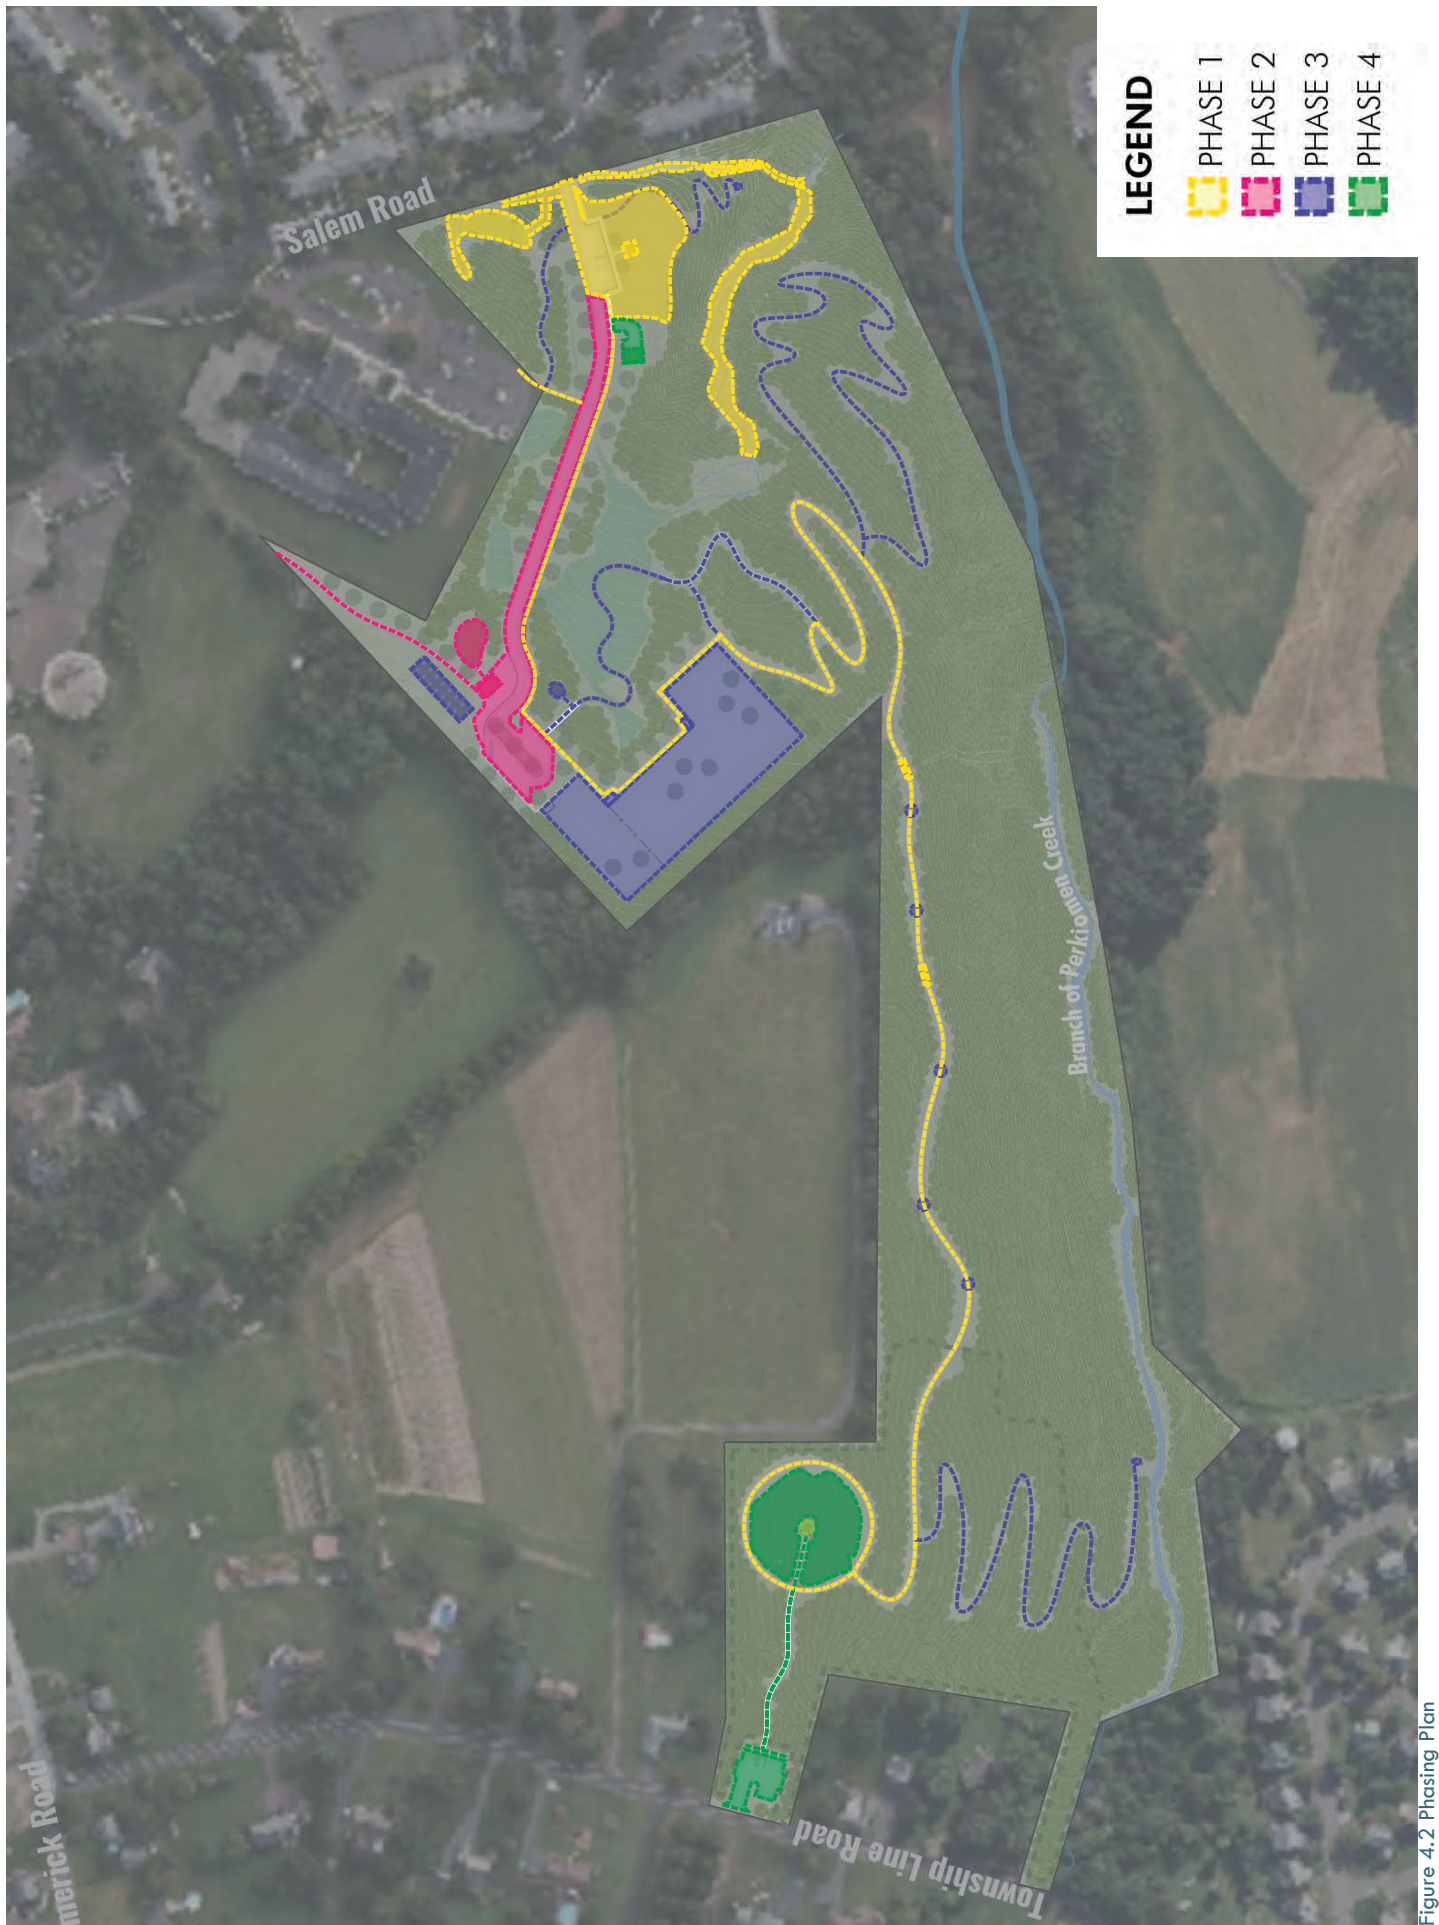
Figure 4.2 Phasing Plan

Phase 4 focuses on the completion of the parking area adjacent to Township Line Road, with the installation of the maintenance building. This work includes the food forest plantings, picnic area with furnishings, and reforestation plantings. It should be noted that the parking area from Township Line Road is not desired, and should not be included in Phase 4 if not deemed necessary for public safety and well-being after Phases 1 through 3 have been built.

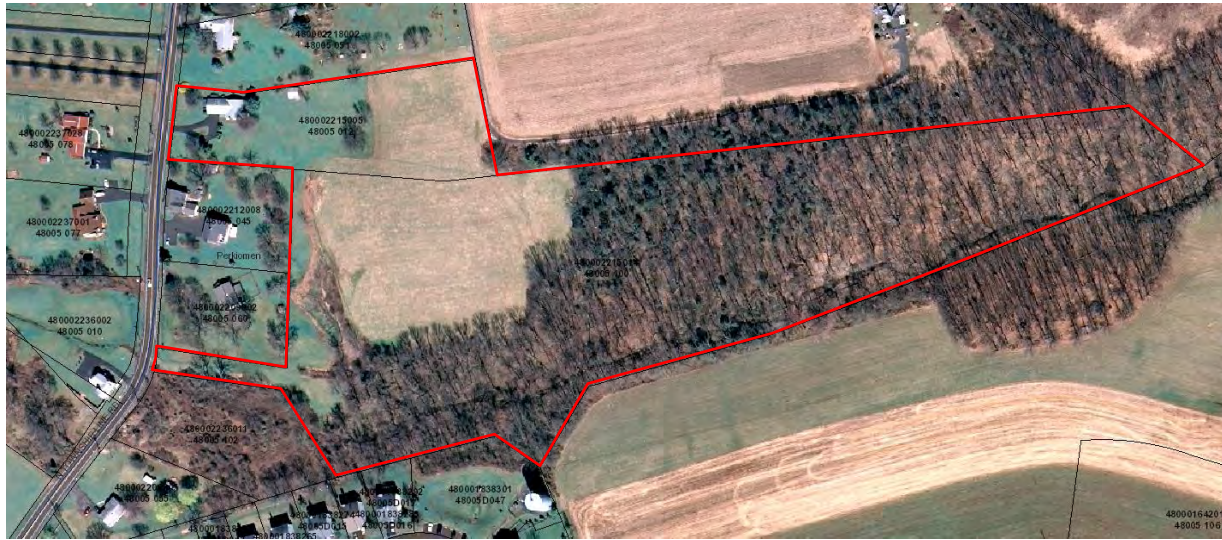
*Image from Google Maps of 546 Township Line Road*

An aerial photograph of a rural property. A road, labeled 'Township Line Rd' in two locations, runs vertically on the left side of the image. The property is characterized by a large green lawn, numerous trees of varying sizes, and several buildings. A large house with a grey roof is visible in the upper left. A smaller building with a red roof is in the upper right. A small grey shed is located in the center. A paved driveway leads from the road to a house in the lower left. Red text '1A' and '1B' are overlaid on the image, indicating specific areas of interest.

(1A) We performed on site investigation to determine the available sight distance at the existing driveway entrance on January 21, 2020 at the 546 Township Line Road Property. The slope of Township Line Road at this location is approximately 4%, going downhill from north to south. This results in a minimum safe sight distance looking out of the driveway to the north (i.e. looking right) of 338 ft, and to the south (i.e. looking left) of 295 ft.

(1B) Due to the sight distance issue at the existing driveway we evaluated sight distances for a potential driveway location on the same property but approximately 70 ft north of the existing driveway location. At this location (designated as 1B) the available sight distance was 475 ft sight distance to the north, which was adequate, and 296 ft to the south, assuming the bush on the adjacent property was removed. This would require property owner cooperation to remove the bush.

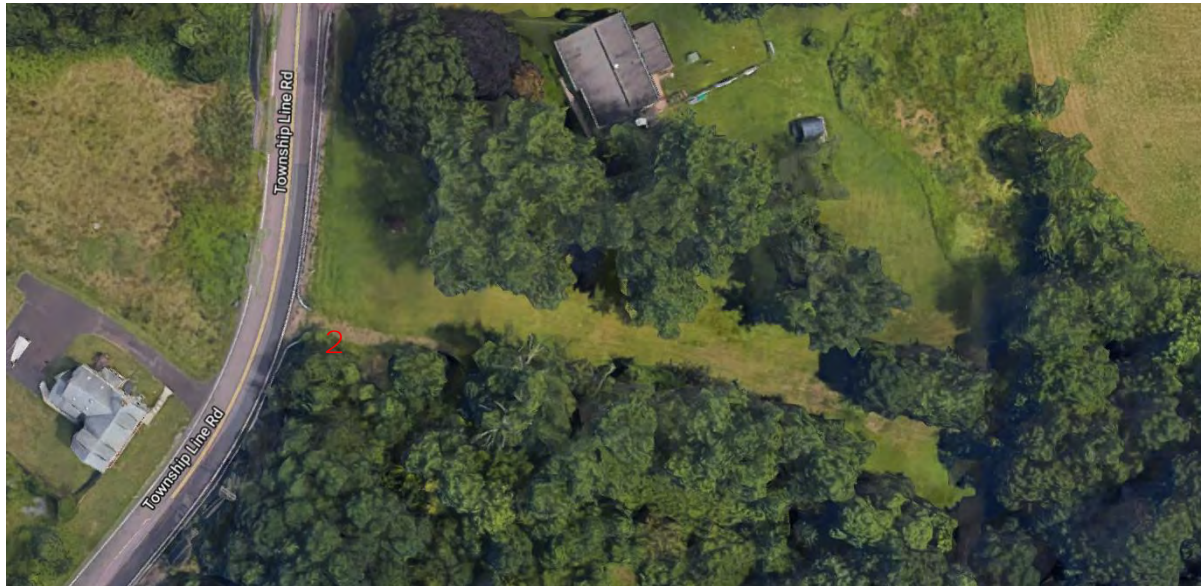
*Image from Google Maps of Right-of-Way Location / Guiderail Opening*

(2) We also performed on-site investigation to determine the available sight distance at the 50 ft wide property frontage at the guiderail opening just south of 542 Township Line Road near a small pipe culvert. The slopes along Township Line Road are approximately 4% downhill from both directions, this location being a low point in the road. This results in a minimum safe sight distance of approximately 338 ft in both directions.

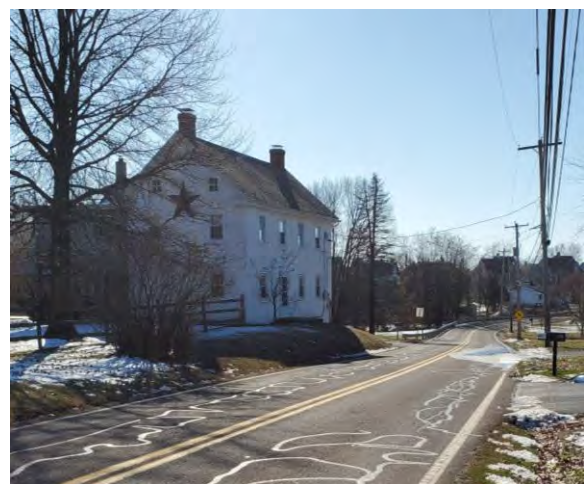
*Obstructions: Plant / Bush & Embankment*

The measured available sight distance was 500+ ft to the north, but only a 240 ft to the south which was 55 ft short of the minimum safe sight distance. There is a large bush and embankment obstructing sight distance to the south. The bush was determined to be an item which could be easily removed with property owner permission; however, the embankment supports the house and cannot be altered; therefore, the minimum sight distance could not be achieved.

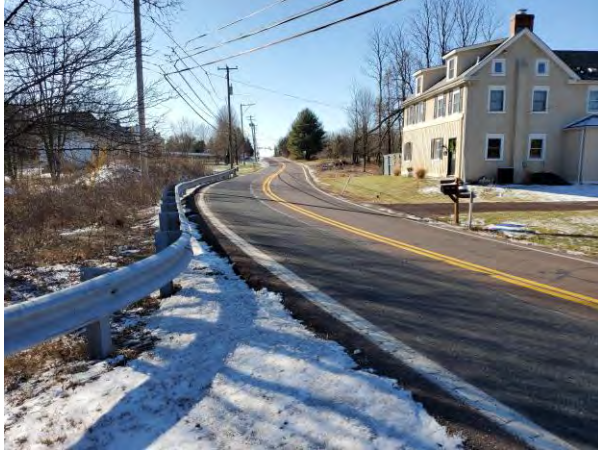
*2 Looking Left*

At this location the available sight distance was 500+ ft to the north and 500+ ft to the south. This would be a feasible location for the driveway based on the available sight distance.

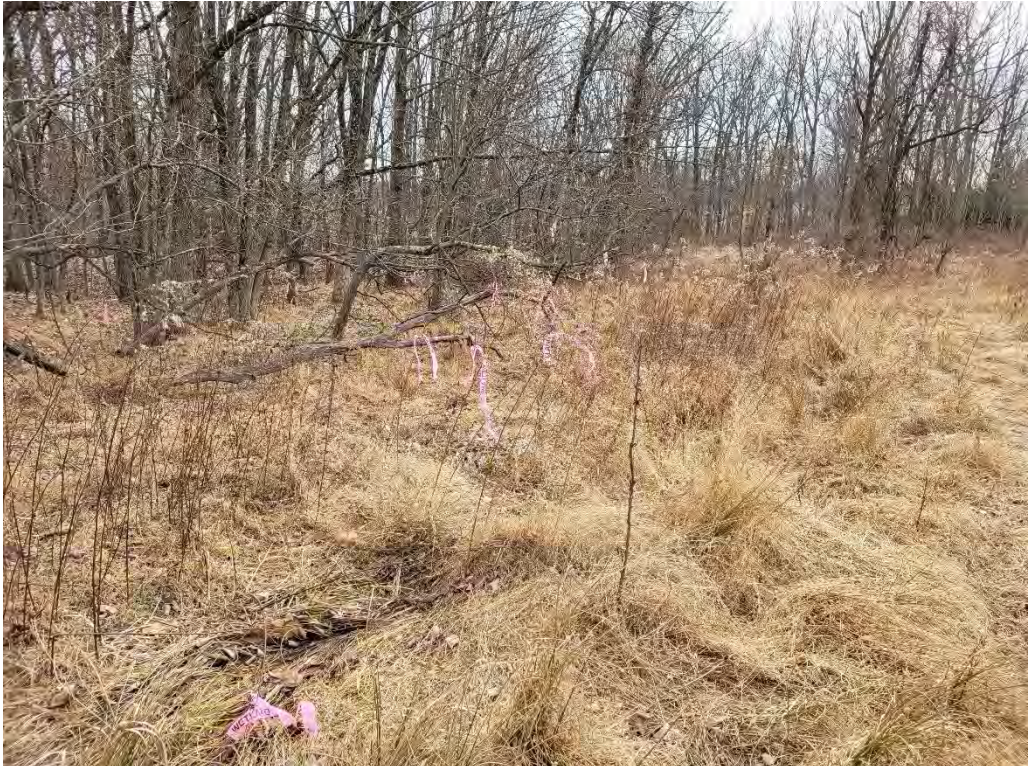
<b>Client Name:</b> Spotts, Stevens, & McCoy		<b>Site Location:</b> Perkiomen Township, Montgomery County, Pennsylvania	<b>Project No.</b> 200688
<b>Photo No.</b> 7	<b>Date:</b> 1/11/21

<b>Direction Photo Taken:</b>  North-northwest			
<b>Description:</b>  View of Watercourse C from C-C43.

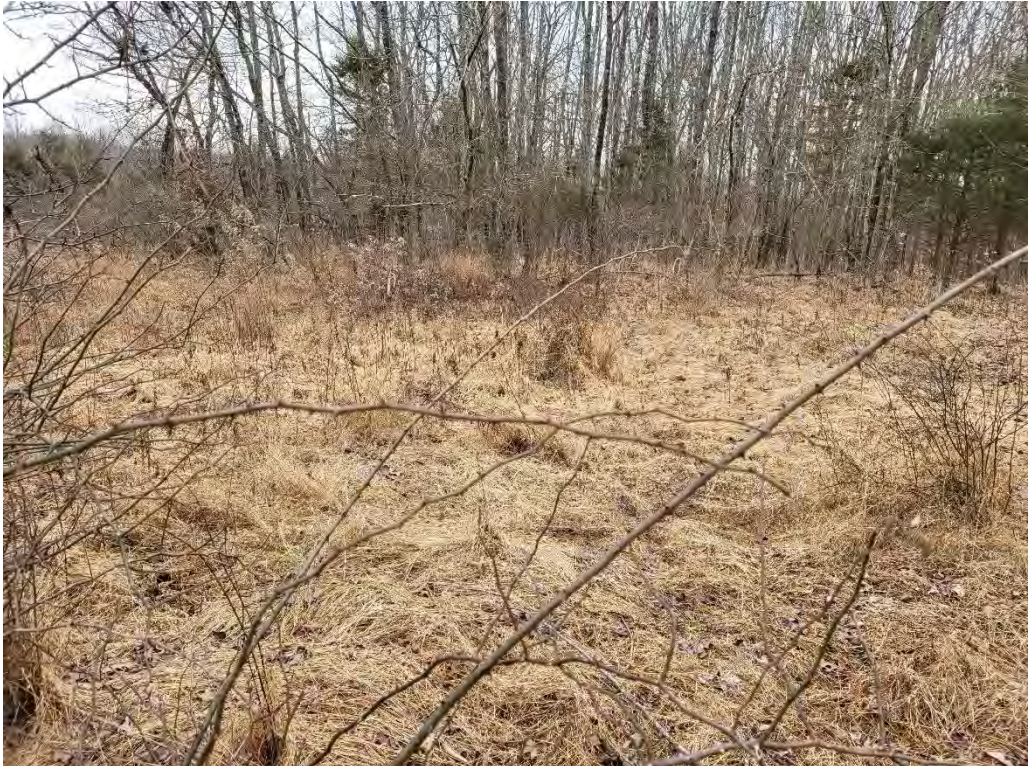
<b>Client Name:</b> Spotts, Stevens, & McCoy		<b>Site Location:</b> Perkiomen Township, Montgomery County, Pennsylvania	<b>Project No.</b> 200688
<b>Photo No.</b> 9	<b>Date:</b> 1/11/21

<b>Direction Photo Taken:</b>  East-northeast			
<b>Description:</b>  View of Wetland E from W-E7.
