# PERKIOMEN TOWNSHIP

## Highland/Huber Park Draft Master Plan

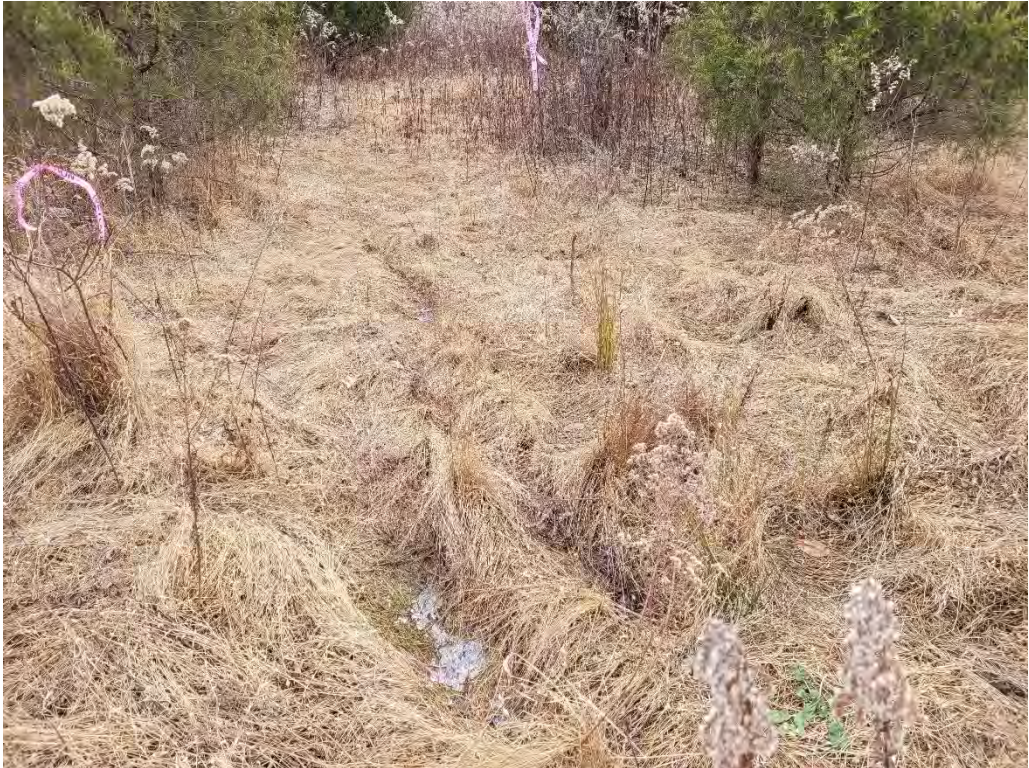
<b>Client Name:</b> Spotts, Stevens, & McCoy		<b>Site Location:</b> Perkiomen Township, Montgomery County, Pennsylvania	<b>Project No.</b> 200688
<b>Photo No.</b> 11	<b>Date:</b> 1/11/21

<b>Direction Photo Taken:</b>  South			
<b>Description:</b>  View of Wetland F from W-F4 closed.

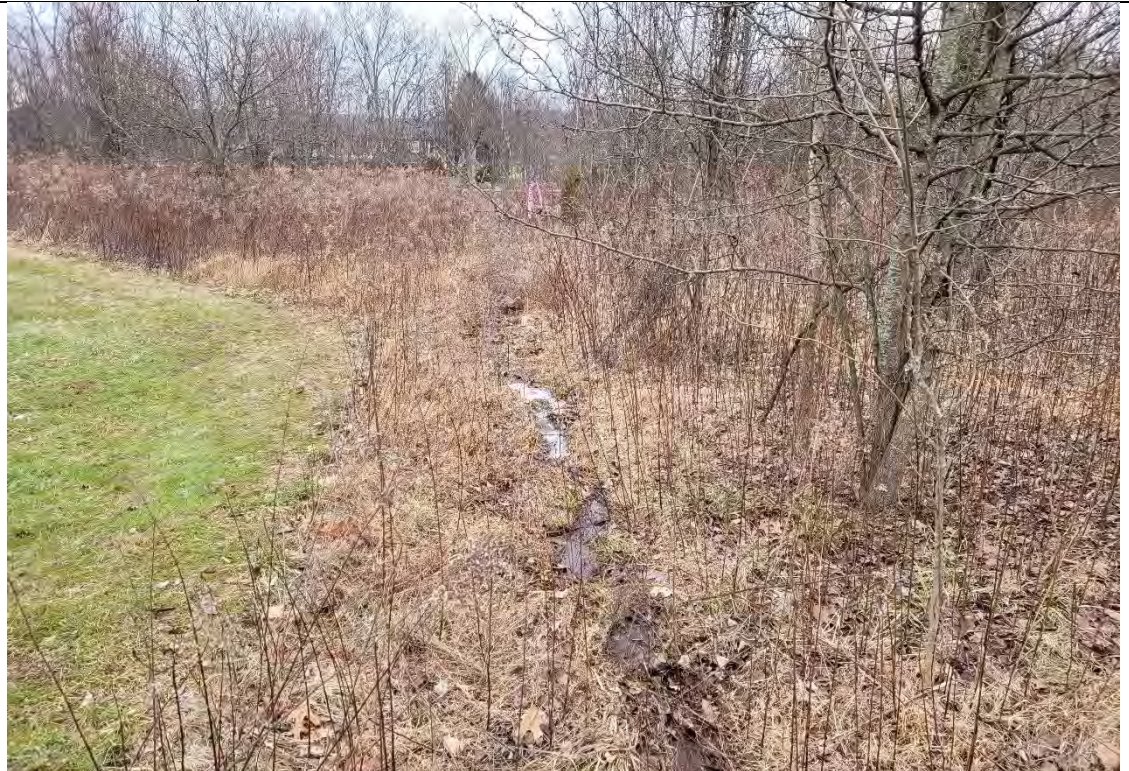
**Description:**

View of Watercourse J  
from C-J103.

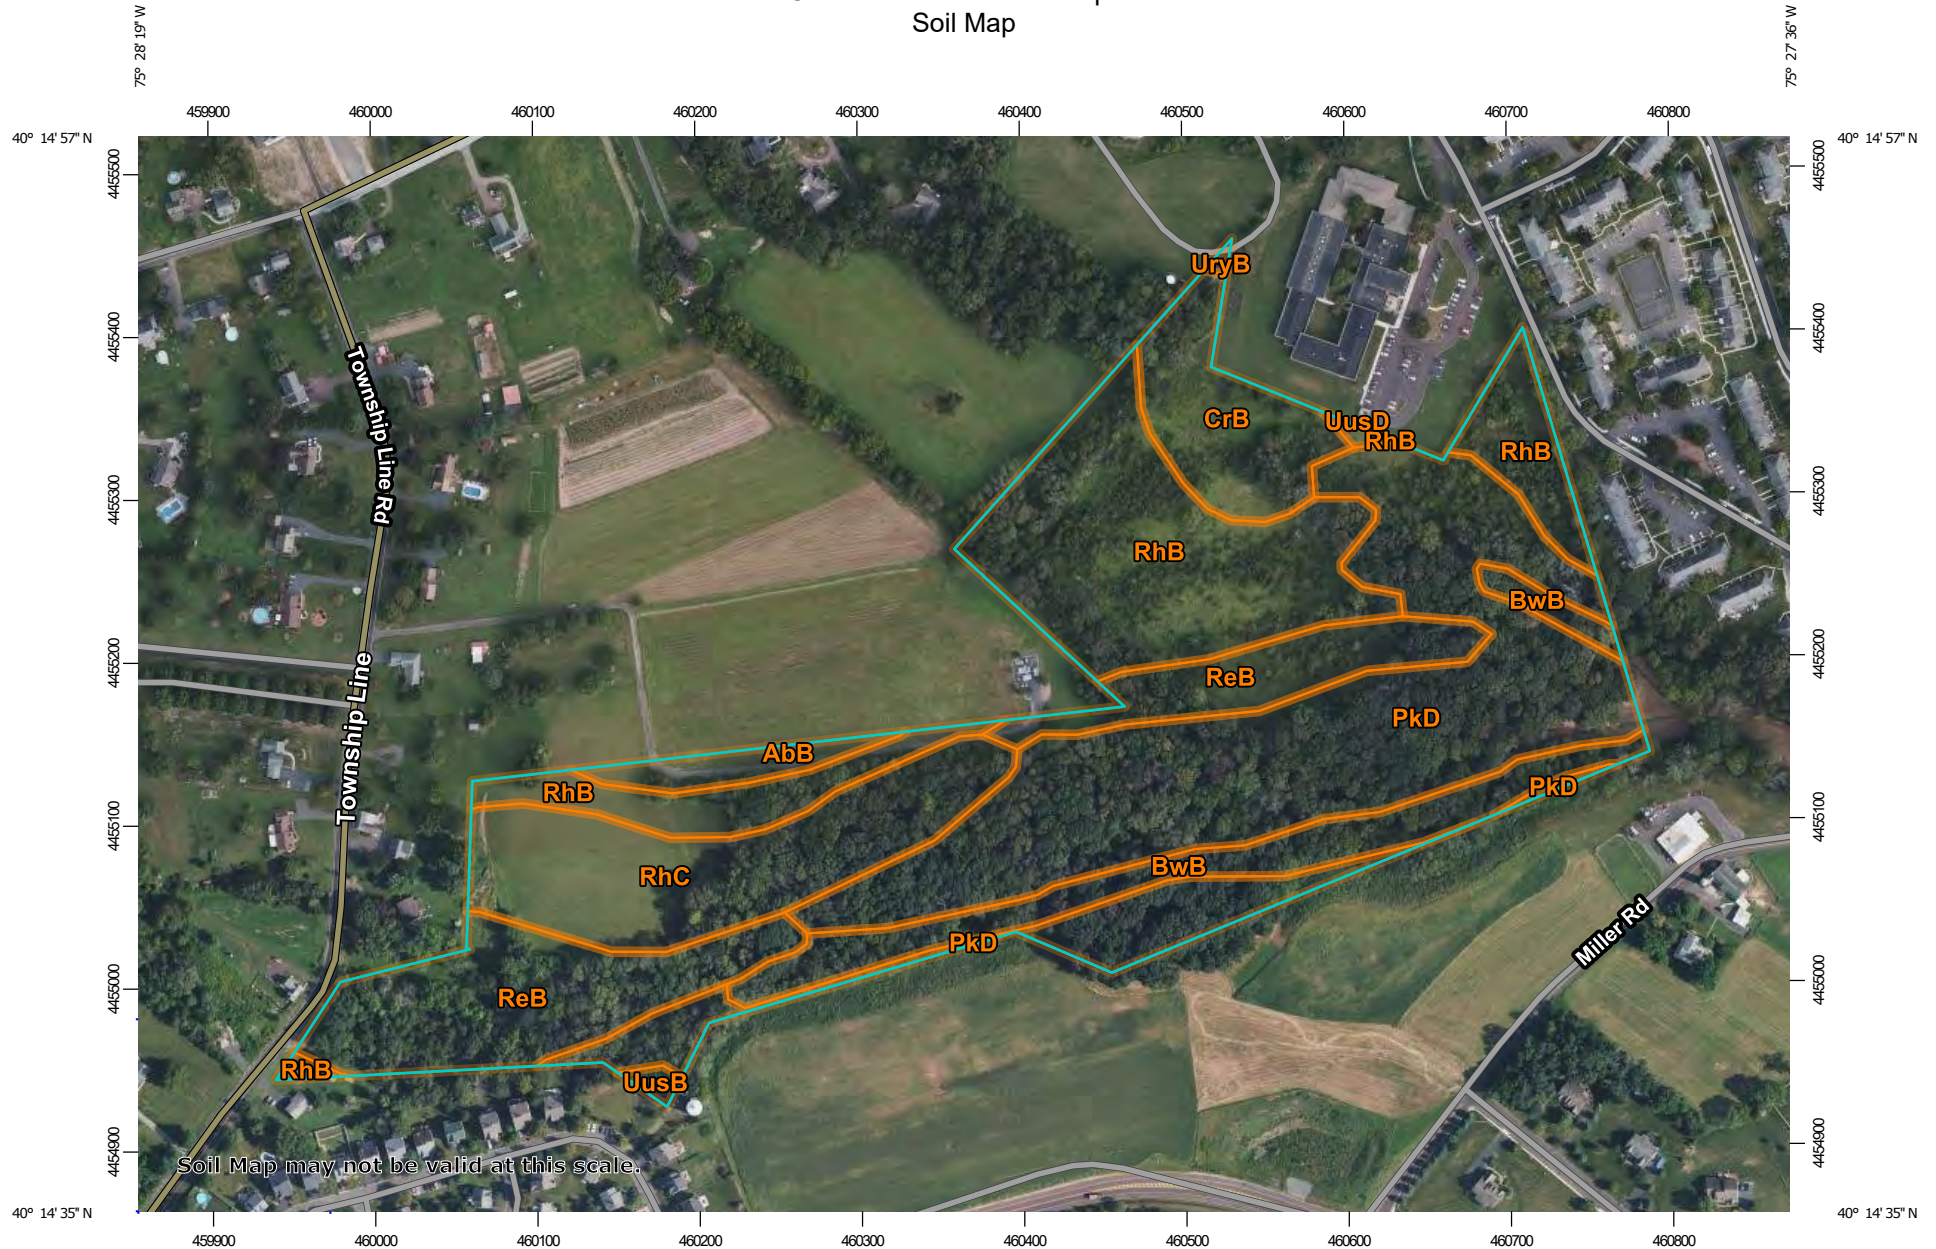
# Custom Soil Resource Report Soil Map

The soil map section includes the soil map for the defined area of interest, a list of soil map units on the map and extent of each map unit, and cartographic symbols displayed on the map. Also presented are various metadata about data used to produce the map, and a description of each soil map unit.
